The earthquake-triggered rock avalanche of Cui Hua, Qin Ling Mountains, P. R. of China—the benefits of a lake-damming prehistoric natural disaster

Johannes T. Weidinger^{a,*}, Jiading Wang^b, Naixi Ma^c

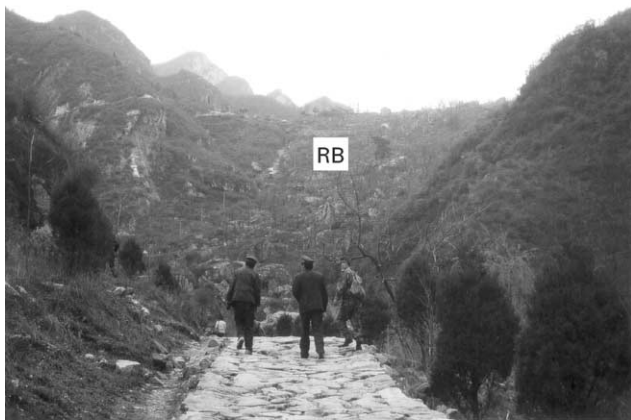
Fig. 3. View from the pathway towards SSE, to the 300m high (from around 800 to 1100 m of elevation) barrier of Cui Hua rock avalanche (RB).

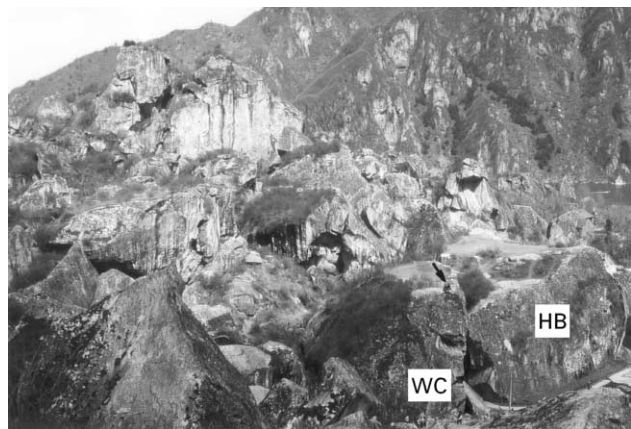
Fig. 5. The centre of the area of largest boulders of the Cui Hua rock avalanche. The total diameter of the largest boulder (HB), which is broken into two pieces (a pathway with the name "wind cave"—WC—leads through it) in the lower right corner is more than 70m (two people are sitting on it, see arrow). It is uncertain whether it was just by chance during avalanching that these two pieces fit together like one.

the Cui Hua rock avalanche is not a real landslide but rather an in situ collapse of a mountain crest that led to a giant blocky stream of rocks with boulders with diameters up to 70 m, which rolled and bounced only for a relatively short distance of about 1 km from southwest to northeast towards and down the valley of Dong Cha. The total volume of all three deposits, which formed a barrier damming Tianchi Lake, is about 350 million m³, enough material to keep the dam stable, even if the impounded lake should be filled during an extraordinary flood event. The upper surface of Cui Hua rock avalanche exhibits huge blocks and boulders. The largest boulders, west of the village on top of the deposit, reach dimensions of 60–70 m in diameter

(Fig. 5). The further the blocks were transported down the valley, the smaller are the boulders. This phenomenon is called in Chinese "Tang Ta Le She".

Nowadays the area around the Cui Hua Peak and especially the material of the rock avalanche in front of the lake play an important role in touristic sightseeing for the nearby capital of Xi'an with its 3 million “nature-hungry” inhabitants. While the lake is good enough for boating and vacationing, the deposit of the rock avalanche can be investigated along several pathways on top of and through canyons between the big boulders. The “Ghost Canyon”, one of the boulders that might have been cracked along microjoints during a later earthquake (Fig. 11), the “Wind Cave” an A-shaped joint through two (formerly one) blocks (Fig. 5) and the “Ice Cave”, which retains ice in winter, when the

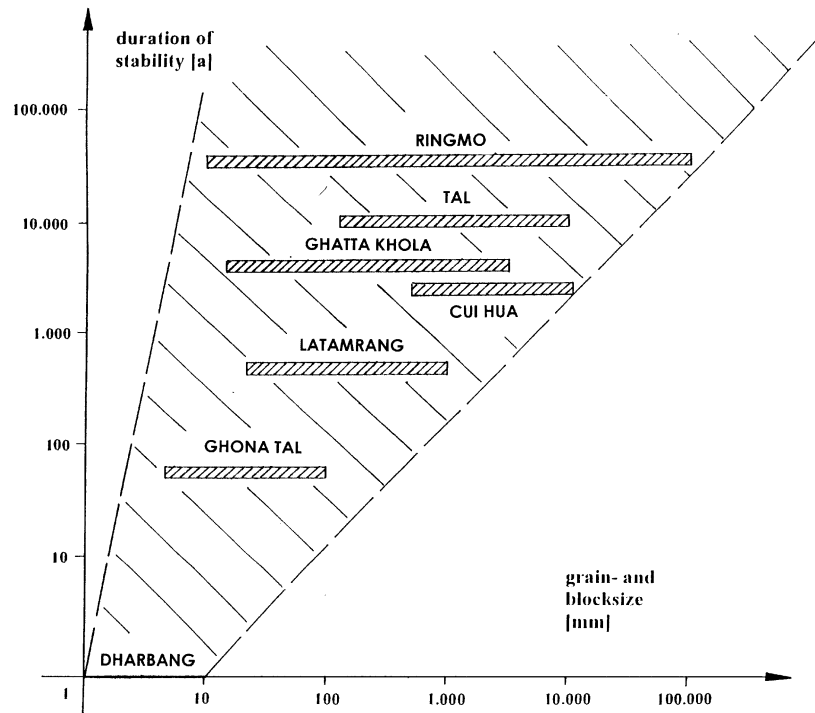
Fig. 8. “Blocksize–Stability” correlation diagram of lake-damming landslides and rock avalanches in the Himalayas (Dharbang, Ghona Tal, Latamrang, Ghatta Khola, Tal, Ringmo) compared with results from the Qin Ling Mountains (Cui Hua).

landslide deposit and the different lithological behaviours of the involved materials, which built up the barriers (Costa and Schuster, 1988; Schuster, 1986). With an isometric shape of the deposit and a volume more than 100 times that of the dammed waters behind, the barrier of the Cui Hua rock avalanche is safe from an outbreak of Tianchi Lake. In this case, the rate of sedimentation into the lake, due to the small catchment area of the Dong Cha River and the small amount of sediments in it, is so low that the lake can hardly be infilled with them. Similar barriers with different (higher rates) conditions of sedimentation, as the Ghona Tal landslide in northern India, have shown that such dammed lakes could rapidly and easily become parts of the geological past, within a period of less than 80 years (Weidinger, 1998). An attempt to find a way concerning the prognosis of the duration of the stability of a lake-damming landslide or rock avalanche was given in a study on similar phenomena in the Himalayas (Weidinger and Ibetsberger, 2000). It is a correlation between the grain, boulder and block sizes of the landslide material and the duration of the stability of a dam, with the result that the bigger the average diameter of the components, the longer the life of the lake. The plot of the data from Cui Hua verifies this rough diagram (Fig. 8). Instead of washing material out of the deposit of the rock avalanche, seeping waters give a stabilizing input by cementing the space between the blocks with fine-grained sediments, which are transported by the water. The benefits of this natural disaster
